SERVICE BULLETIN

Date: 5/23/2005
Service Bulletin #: PDSBLTN-002, RWSBLTN-230505
Subject: Inspection of Tandem VTC-III reserves (VR-360) A Line Attachments and Steering Lines.
Status: MANDATORY

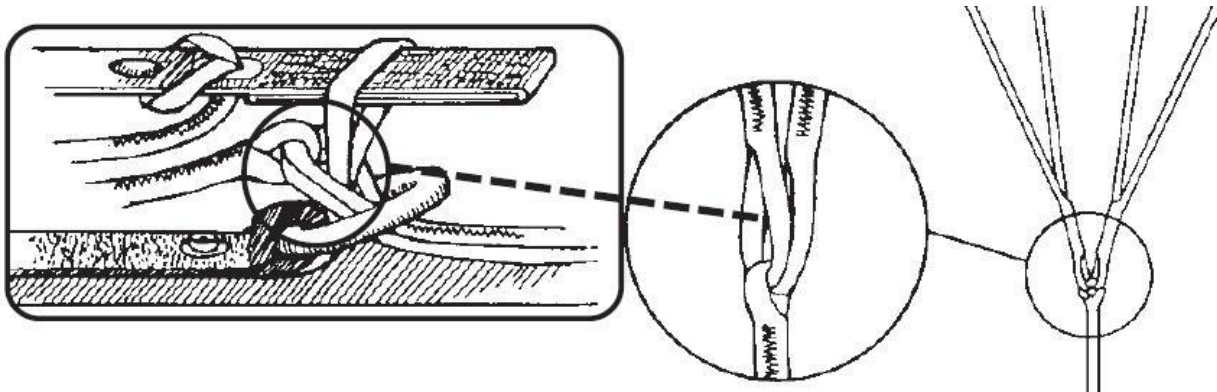
Correct Brake Setting

Some VR-360's were manufactured with the lower control line loop to be as large as the upper control line loop at the cascade. While there is no impact to the structural integrity, or performance of the canopy, this situation opens the possibility for the riser brake-setting loop to be misrouted through the lower control line instead of the correct location in the upper control line as shown below. Improperly set brakes can result in brake line failure during opening and unusually high opening forces.

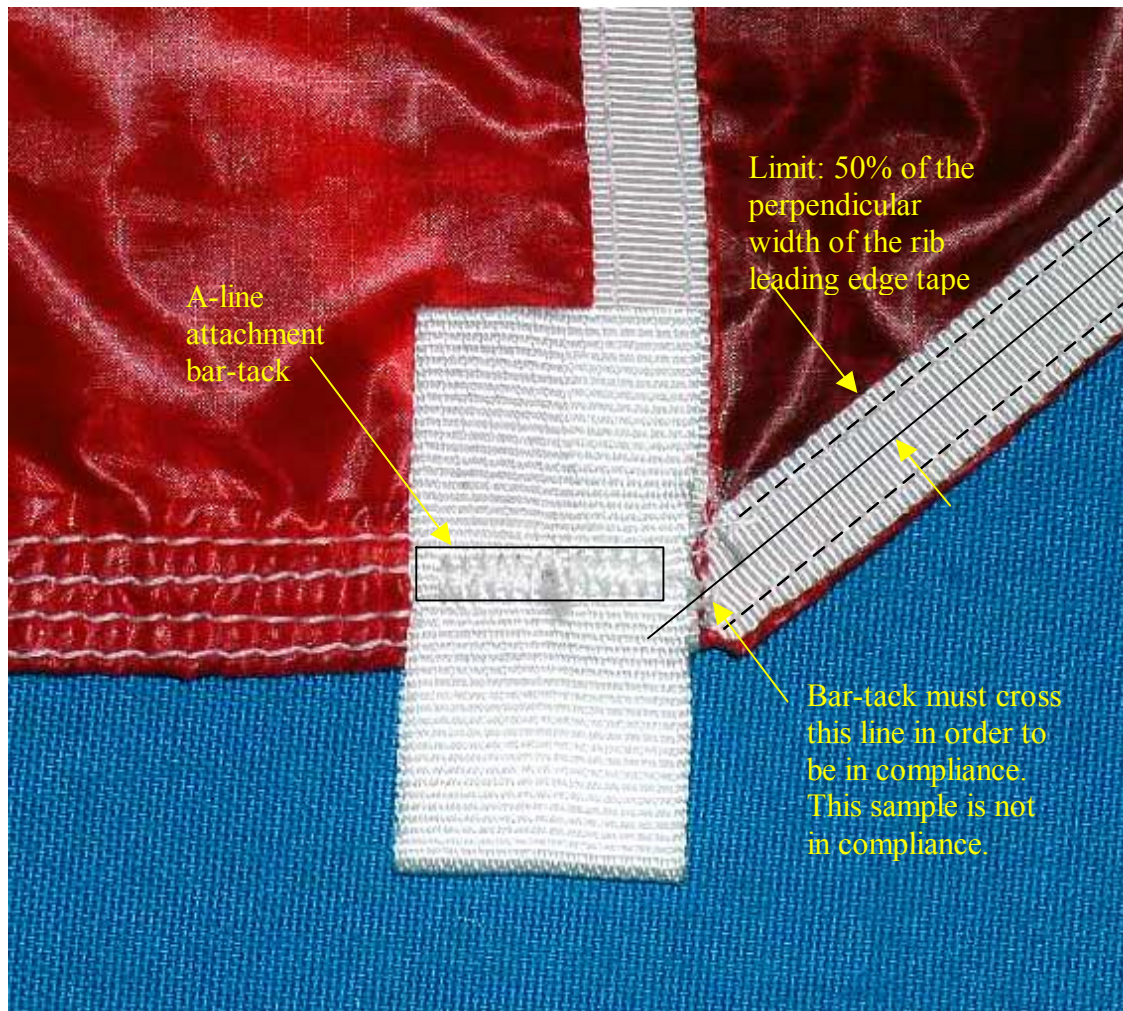
Figure 1 Rib leading Edge Tape Inspection

The A-line attachment bar-tack must be sewn through at least 50% of the width of the loaded-rib leading edge tape.

- Using a ruler, find the centerline of the rib-leading edge tape. This may be lightly marked with pencil if necessary.
- Using the ruler, extend the centerline of the leading edge tape to the vicinity of the bar-tack.
- Observe the location of the bar-tack with respect to the tape centerline.

1. Inspect all ten of the A-line attachments per the attached Inspection Procedures, Section 1, A-line Attachment Inspection Procedure.
2. If any of the 10 A-line tab bartacks do not comply with the proper alignment the parachute must be brought into compliance by an approved service facility. Adjusting the line tab requires a specialized heavy-duty bartacker not commonly found in the field.

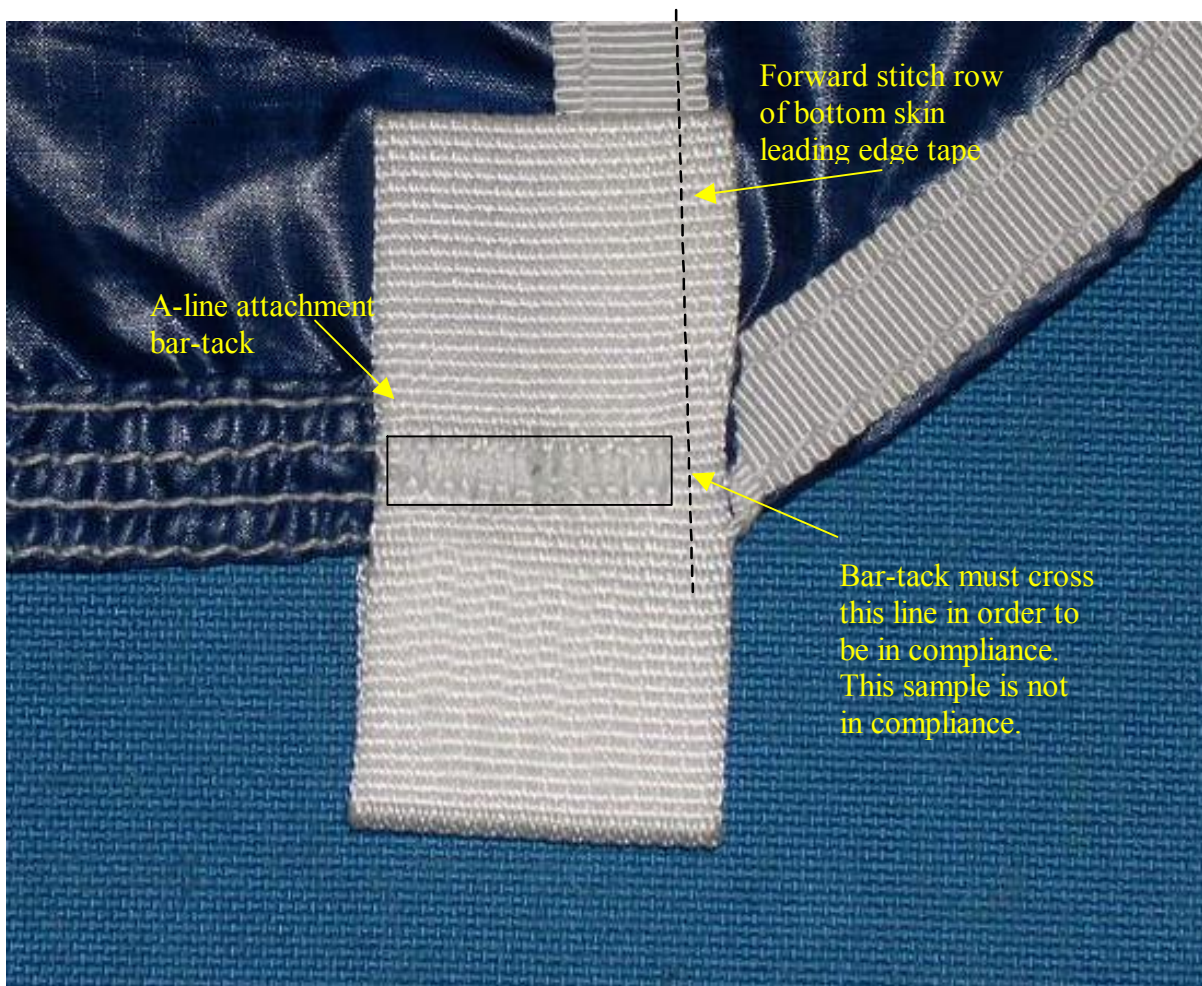
Figure 2- Bottom Skin LE Tape Inspection

The A-line attachment bar-tack stitching must extend forward of the forward stitch line on all the bottom skin leading edge tapes. Inspect both sides of tab.

- a) Locate the forward stitch row of the bottom-skin leading edge tape.
- b) Using a straight edge, extend the forward stitch line of the leading edge tape to the vicinity of the bar-tack.
- c) Observe the location of the bar-tack with respect to the tape stitch row. The bar-tack may or may not overlap the edge of the line-tab, but it must cross the stitch-row and be going through the tab at this point.

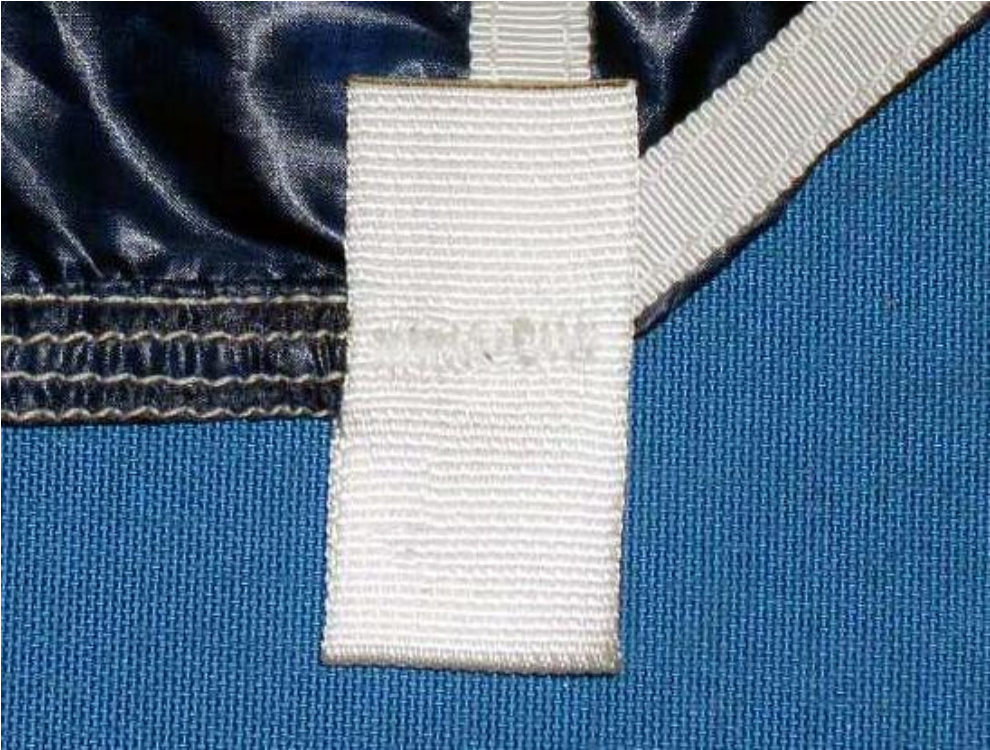
Figure 3 Acceptable Line Attachment Bar Tack

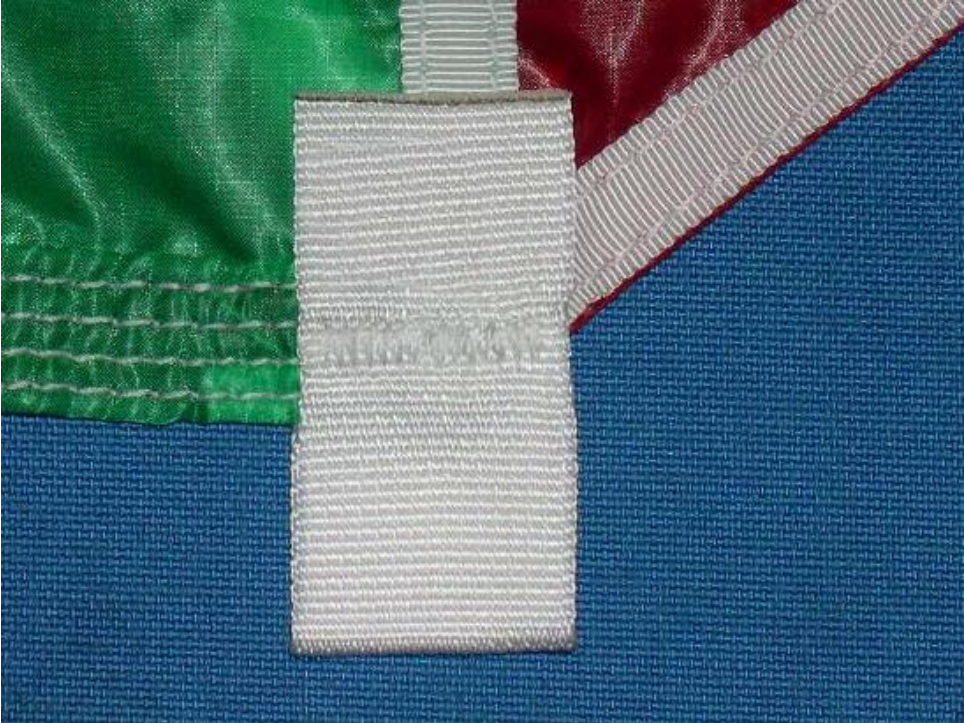
Figure 4 Acceptable Line Attachment Bar Tack

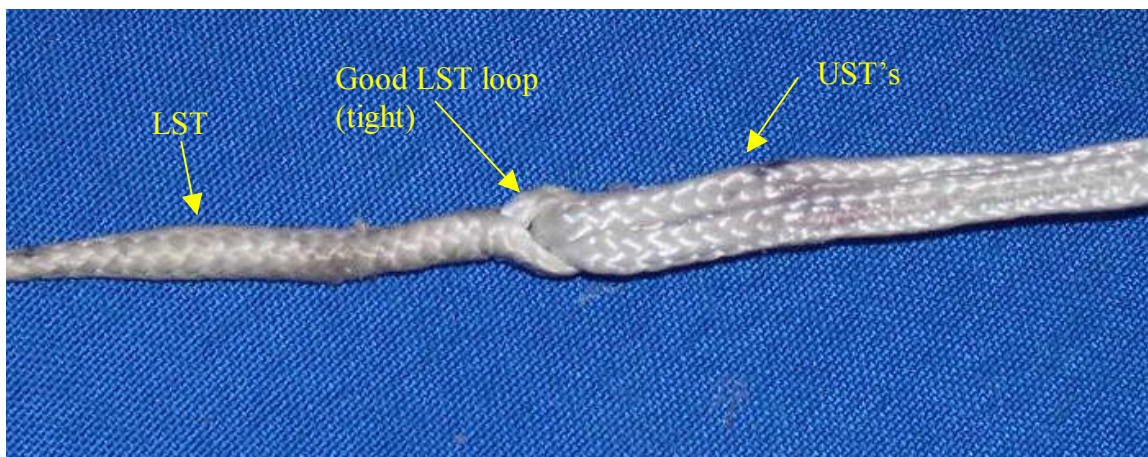
Check each of the LST's (lower steering lines, the line that passes through the toggles) where it loops around the UST (upper steering line). This loop must be small enough that the brake setting loop on the risers cannot be pulled through.

Figure 5 Good LST Loop

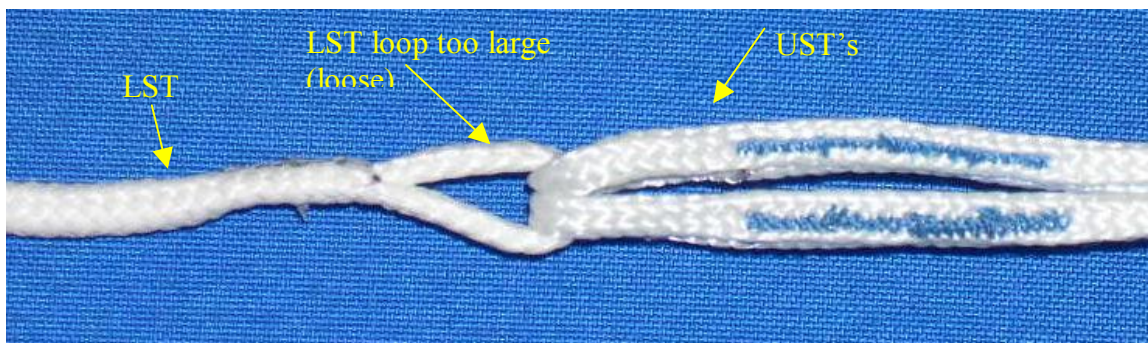
Figure 6 - LST Loop too large

The LST loop may be reduced to an acceptable level by adding a bar-tack or zigzag stitch to reduce the open legs of the loop. The following includes directions for reducing the existing LST loop.
