Service Bulletin 2023-001

Subject: Zig zag stitching on main container flap #2

SIFE harness & container systems in all container sizes.

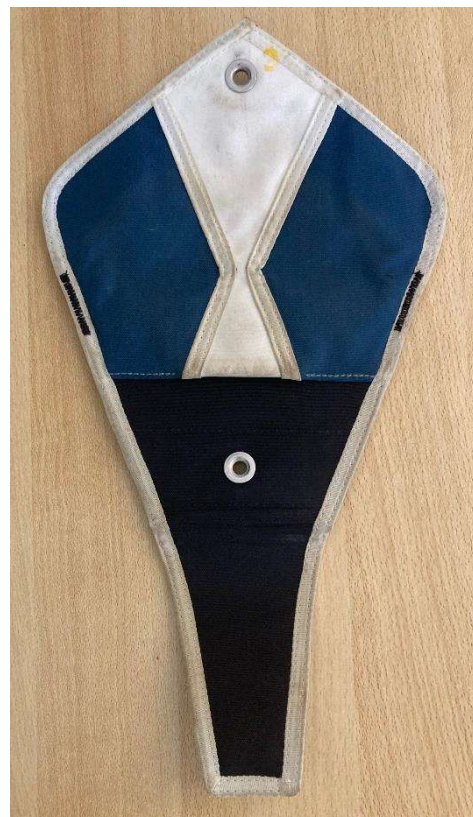
We have been informed that during the activation of the main canopy, one suspension line of the left rear suspension lines caught on the main container flap #2.

Unfortunately, we didn't have the chance to inspect the affected harness and container system to find out the concrete reason why the line was caught on the main container flap #2.

During the pack job the lines had to be laid under the reserve container as described on page 50 in our OWNER MANUAL as **WRONG** and the main canopy had to have a pulling direction which would be due to an unstable body position.

Before the next reserve repack your rigger may strengthen the main container flap #2 with a zig zag stitching as shown on the picture between the two red lines. Start at the end of the binding, where the flap is attached to the reserve container and end at the beginning of the stiffener (red lines in the picture below). Overstitch your zig zag stitching once.

Don't stitch over the two bindings (green circle in the picture below) because there are already two bar tacks under the binding. You don't have to separate the flap from the reserve container while doing the zig zag stitching.
